PHOTOGRAPHIC SURVEY OF THE LDEF MISSION

NASA Special Publication 531

Robert L. O'Neal

Langley Research Center
Hampton, Virginia 23681-0001

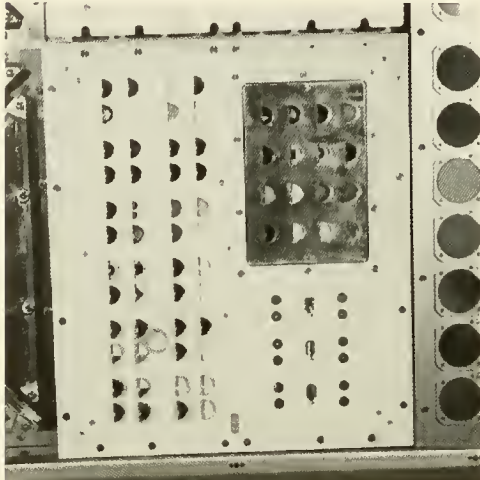
Figure 257
Photo No.: KSC-390C-1538.03
Dup. Neg. No.: L91-8841
LISAR No.: EL-1994-00693
Photo Credit: KSC
Photo Date: 3/2/90
Location: KSC SAEF II
Subject: Postflight Detail of Lower Part of Tray C9

Figure 257 (Postflight). This photograph is of the lower one-sixth of the tray. Experiment AO114 shows a little change in the color of the white paint. A very faint tan tint exists around the outside edges of the cover plate and the outside ring of fasteners. The material specimens remain intact in their mountings and seem to have survived well the exposure to the space environment. The polished aluminum cover plate has darkened and seems to have a duller finish than in the preflight photograph.

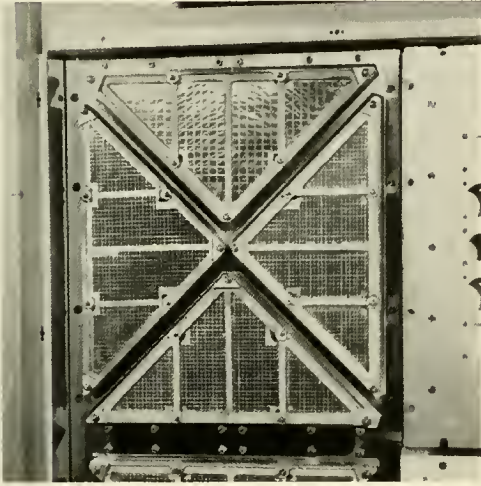
Figure 259 (Postflight). This photograph is of the upper left one-sixth of the tray. The sensor foils are intact, but some areas of the mounting frames appear discolored.

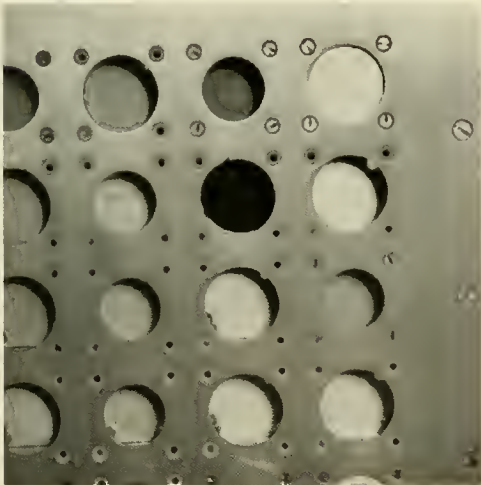
Figure 260 (Postflight). This close-up is of a portion of the upper center one-sixth of the tray. The test specimens appear intact. Some shadows appear on some of the recessed test specimens.

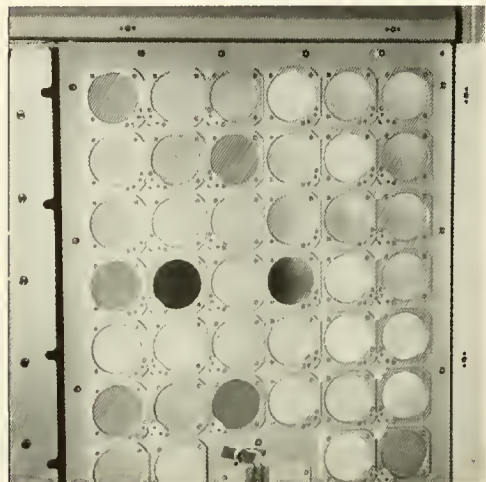
Figure 261 (Postflight). This close-up is of the upper right one-sixth of the tray. The impact sensors are intact. The different colors are reflections of the surrounding area. Evidence of space debris impacts are visible on some of the lighter colored sensors. Some light discoloration is visible around the baseplate fasteners.

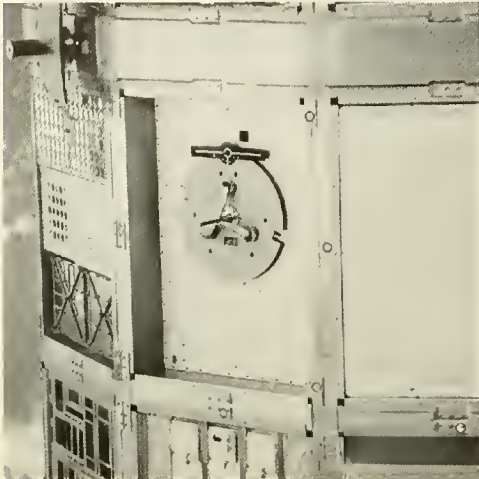
Figure 263 (In Flight). The grapple tray assembly appears to be without physical damage. The color of the tray and surrounding areas of the LDEF have a somewhat unrealistic pink or orange cast. The dark gray circular discolorations on the outer section of the grapple fixture appear to be the locations of impact craters where the surrounding surface coating has been disturbed.

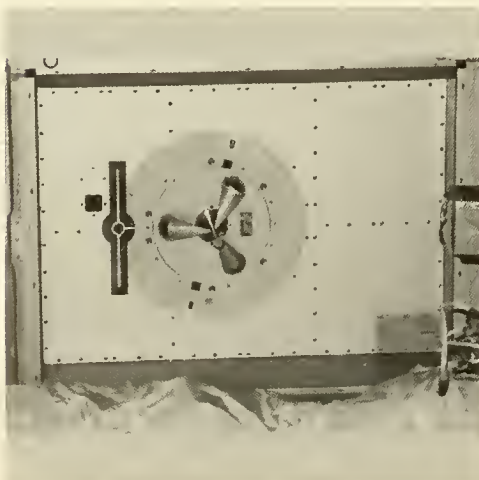
Figure 264 (Postflight). The grapple tray assembly is without physical damage. The chromic anodized aluminum mounting plate is in prelaunch condition with only a very light tan discoloration. The aluminum cover plate located in the lower right corner of the tray has a number of irregular darker discolorations around the outer edges that appear to be fingerprints. The dark gray circular discolorations on the outer section of the grapple fixture are impact craters where the surrounding surface coating has been disturbed.

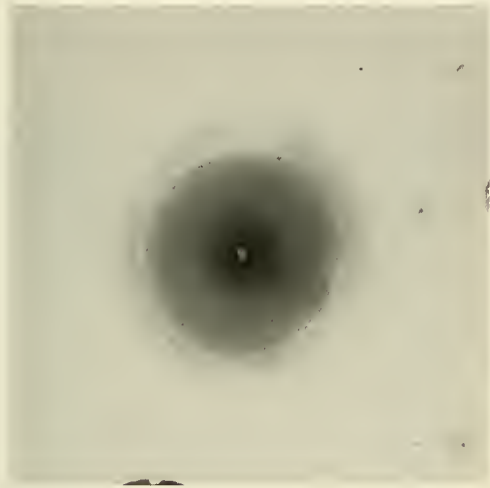
Figure 265 (Postflight). This close-up is of one of the impact craters on the grapple fixture. Other small impact areas are visible.

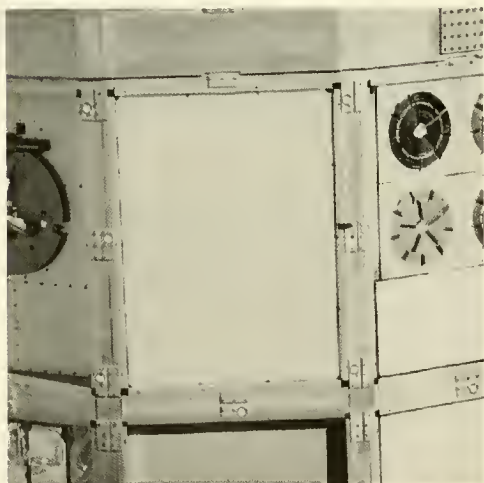
Figure 266 (In Flight). The thermal cover surface appears to have changed from specular to opaque. There are indications of a number of impacts on or penetrations of the thermal cover. The cover is more taut than in the prelaunch photograph and the locations of Velcro attachment pads are apparent. The ground strap is in place with no visible damage, but it is a darker color.

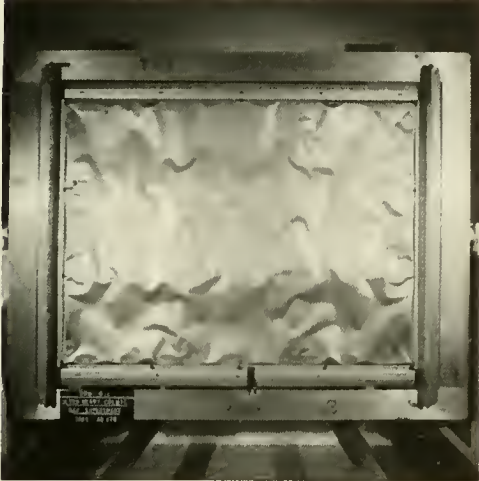
Figure 267 (Postflight). The thermal cover surface appears to have changed from specular to opaque with many black dots of various sizes that indicate impacts on or penetrations of the thermal cover. Photographic light reflections wash out many of the details. The cover is not as taut as in the in-flight photograph and locations of Velcro attachment pads are not as prominent. The ground strap is in place with no visible damage, but it is a deeper copper color.

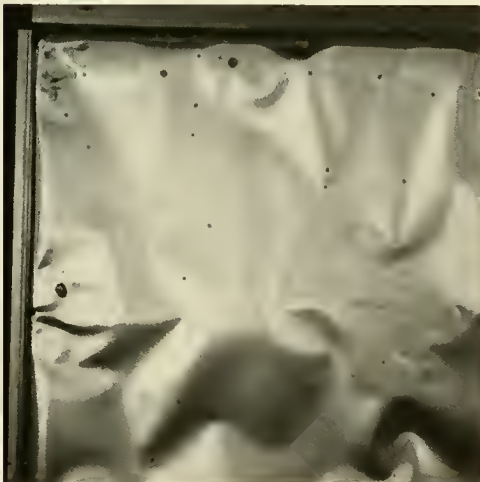
Figure 268 (Postflight). This photograph is of the upper left one-sixth of the tray. The thermal cover appears opaque rather than specular as it was in preflight photographs. The numerous discolorations indicate impacts on or penetrations of the thermal cover. The Velcro thermal cover attachment pads are evident.

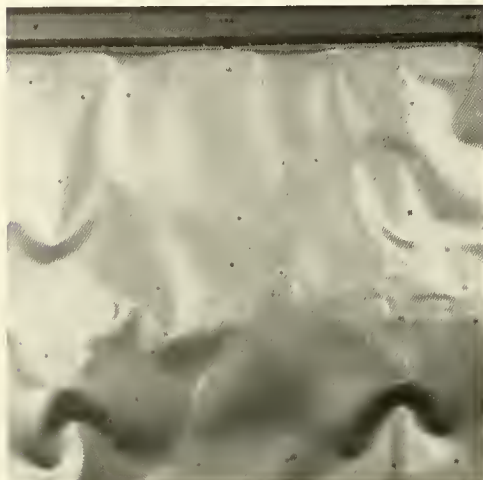
Figure 269 (Postflight). This photograph is of the upper center one-sixth of the tray. The thermal cover appears opaque rather than specular as it was in preflight photographs. The numerous discolorations indicate impacts on or penetrations of the thermal cover. The Velcro thermal cover attachment pads are evident.

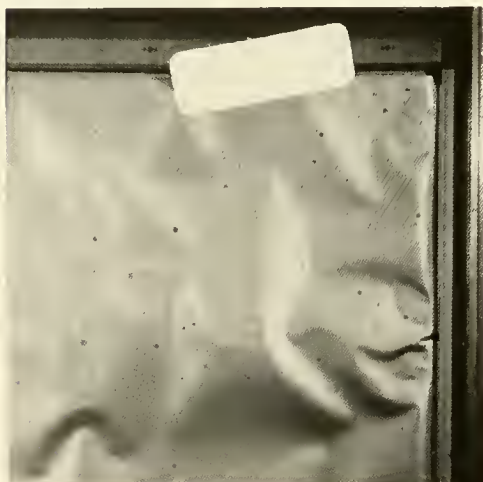
Figure 270 (Postflight). This photograph is of the upper right one-sixth of the tray. The white area at the upper edge is a result of darkroom film splicing. The thermal cover appears opaque rather than specular as it was in preflight photographs. The numerous discolorations indicate impacts on or penetrations of the thermal cover. The Velcro thermal cover attachment pads are evident.

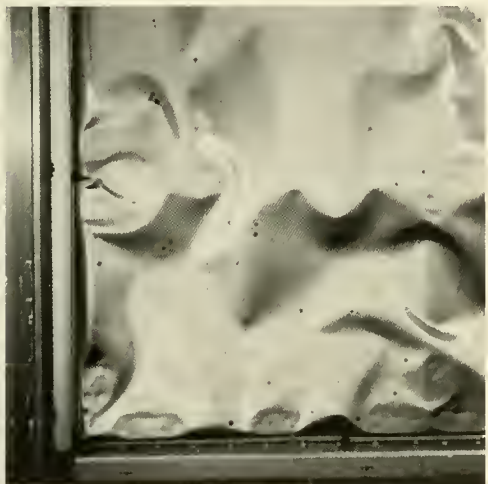
Figure 271 (Postflight). This photograph is of the lower left one-sixth of the tray. The thermal cover appears opaque rather than specular as it was in preflight photographs. The numerous discolorations indicate impacts on or penetrations of the thermal cover. The Velcro thermal cover attachment pads are evident.

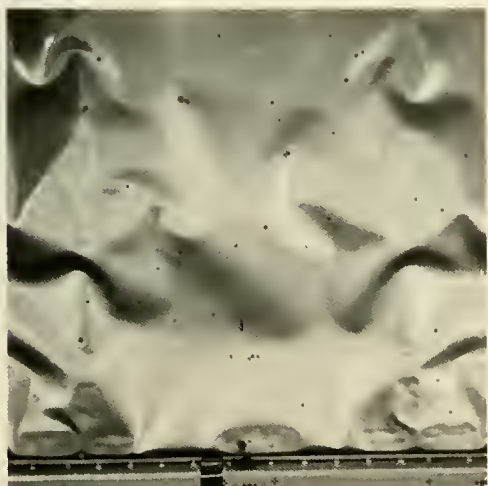
Figure 272 (Postflight). This photograph is of the lower center one-sixth of the tray. The thermal cover appears opaque rather than specular as it was in preflight photographs. The numerous discolorations indicate impacts on or penetrations of the thermal cover. The Velcro thermal cover attachment pads are evident.

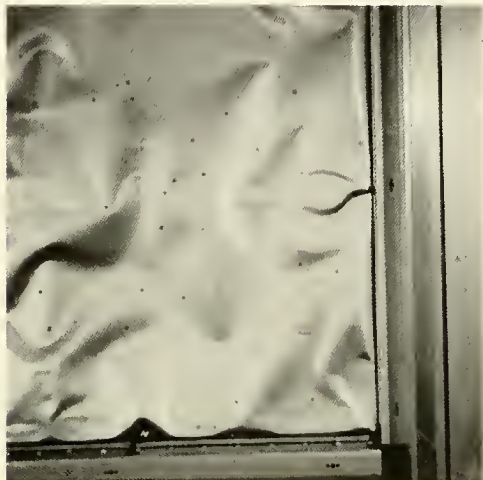
Figure 273 (Postflight). This photograph is of the lower right one-sixth of the tray. The thermal cover appears opaque rather than specular as it was in preflight photographs. The numerous discolorations indicate impacts on or penetrations of the thermal cover. The Velcro thermal cover attachment pads are evident.

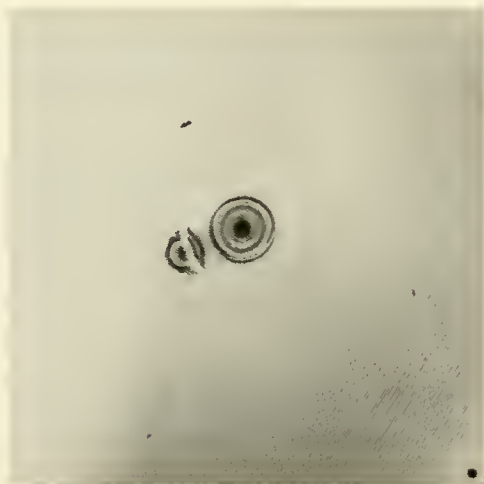
Figure 274 (Postflight). This close-up is of two impacts or penetrations with overlapping discolored areas on tray C11.

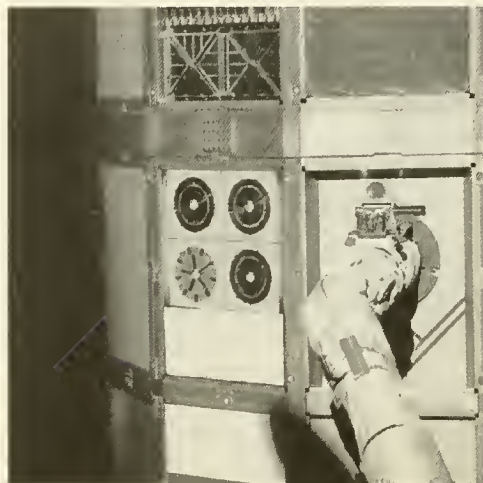
Figure 276 (In Flight). The experiment appears to be without physical damage. The colors of two of the four exposed coils of the fiber optic cables have changed significantly. The cable located in the upper right corner, originally a bright orange, appears to be dark brown and the cable in the lower left has changed from a light blue to a blue gray. Two brown circular discolorations have appeared. One discoloration is on the lower edge of the mounting plate in the upper left and one is on the upper edge of the mounting plate in the lower right. Dark brown irregular-shaped discolorations are visible along the lower edge and on each of the vertical edges of the cover plate.

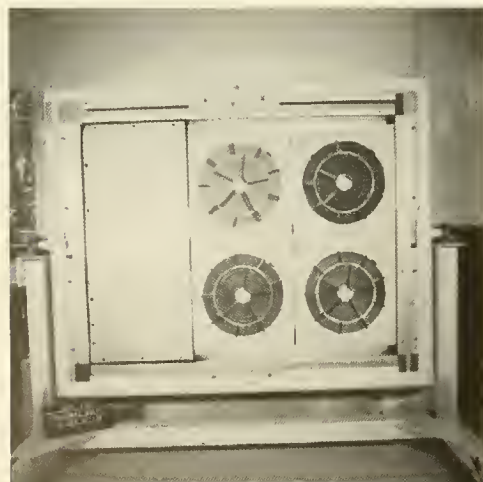
Figure 277 (Postflight). The colors of two coils of the externally mounted fiber optic cables have changed significantly from preflight. Four dark brown areas of discoloration are visible around the openings to the tray interior; these openings are located in the vertical seam between the mounting plates. Dark brown irregular discolorations are also visible along the vertical and upper edges of the cover plate. An irregular vertical stain (not observed in the in-flight photograph) on the upper right corner of the cover plate is now visible.

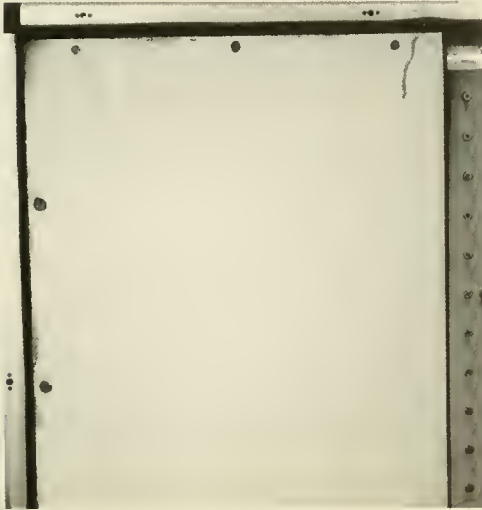
Figure 278 (Postflight). This photograph is of the upper left one-sixth of the tray. The cover without cable has extensive brown contamination along the left and upper edges and around the fasteners. There is a postretrieval liquid run on the upper right corner area of the cover. The existence of a liquid after almost 6 years in space was a surprise. There is also a flow pattern extending from the top edge near the left corner.

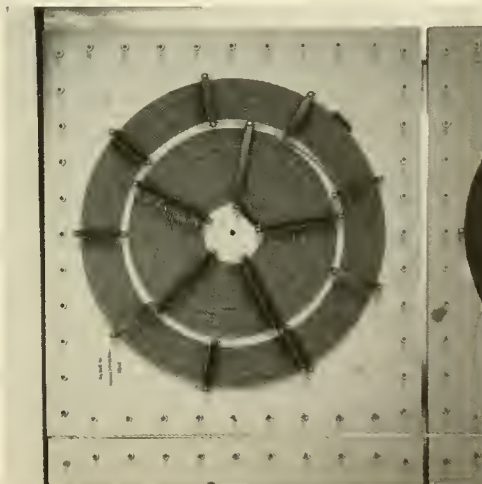
Figure 279 (Postflight). This photograph is of the upper center one-sixth of the tray. The cable has changed from a light blue to a blue gray. The color of the silicone-rubber spacers under the coil attachment clips have changed from clear to brown and have discolored the fiber coils in areas adjacent to the spacers. A flow pattern of discoloration appears to extend downward from fasteners used to secure the four mounting plates.

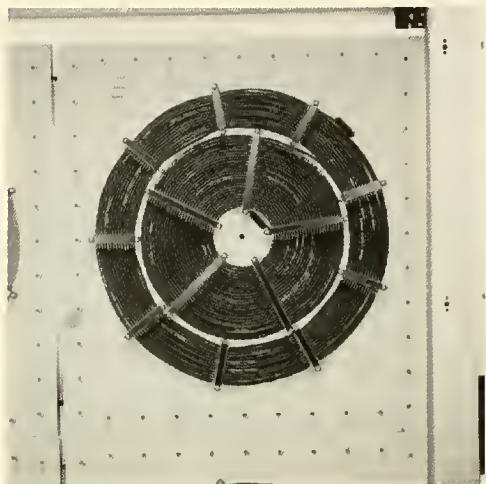
Figure 280 (Postflight). This photograph is of the upper right one-sixth of the tray. The silicone-rubber spacers under the coil attachment clips have changed from clear to brown and have discolored the fiber coils in areas adjacent to the spacers.

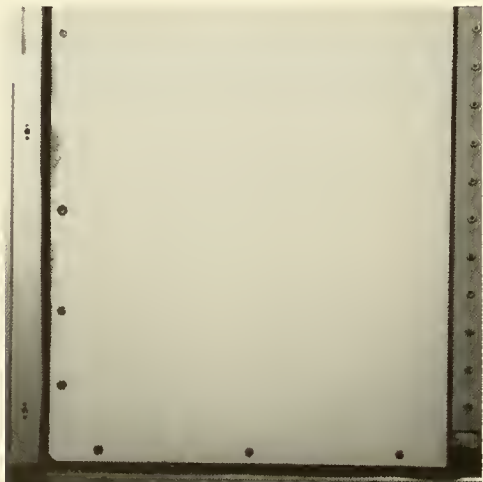
Figure 281 (Postflight). This photograph is of the lower left one-sixth of the tray. The cover without cable has extensive brown contamination along the left edge. There is also a flow pattern extending up from the bottom edge.

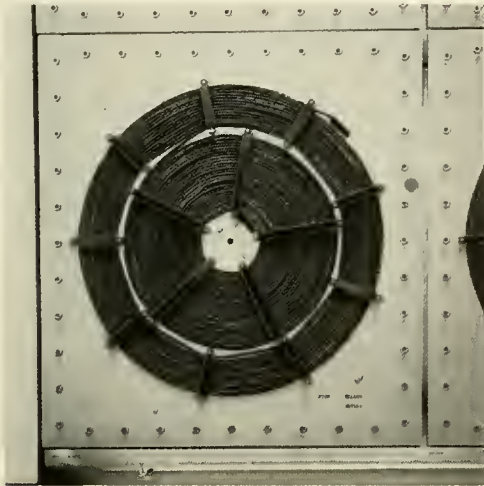
Figure 282 (Postflight). This photograph is of the lower center one-sixth of the tray. The silicone-rubber spacers under the coil attachment clips have changed from clear to brown and have discolored the fiber coils in areas adjacent to the spacers. A flow pattern of discoloration appears to extend downward from fasteners used to secure the four mounting plates.

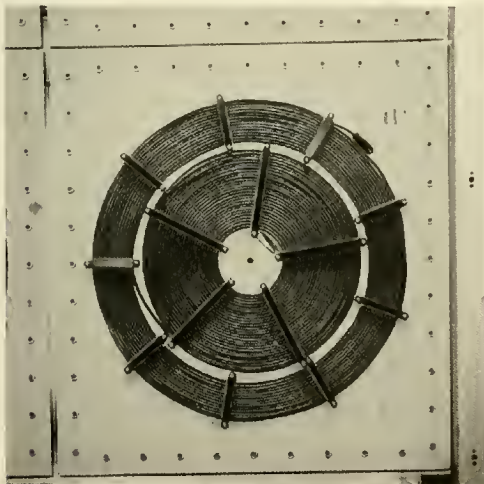
Figure 283 (Postflight). This photograph is of the lower right one-sixth of the tray. The cable, originally a bright orange, is dark brown. The silicone-rubber spacers under the coil attachment clips have changed from clear to brown and have discolored the fiber coils in areas adjacent to the spacers. A flow pattern of discoloration appears to extend downward from fasteners used to secure the four mounting plates.

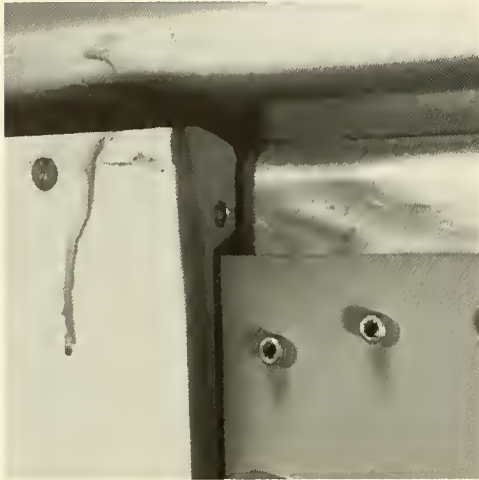
Figure 284 (Postflight). This close-up photograph is of the postretrieval liquid run on the upper right of the cover without cable cover, which is shown in figure 278. Note the extensive brown contamination in the upper center.

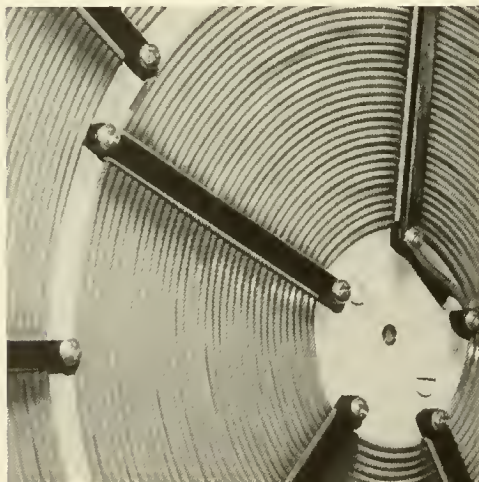
Figure 285 (Postflight). This close-up photograph is of the upper center coil, which shows the silicone-rubber spacers under the coil attachment clips. The spacers have changed from clear to brown and have discolored the fiber coils in areas adjacent spacers.

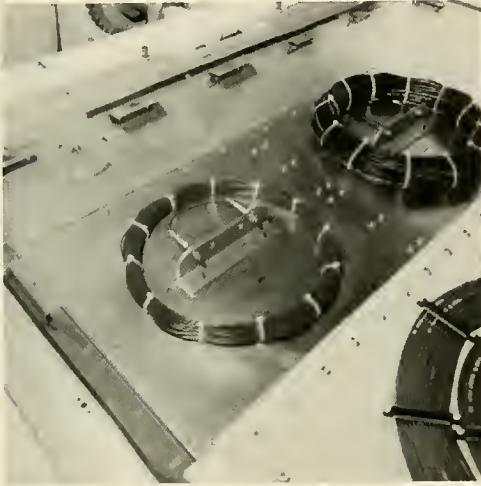
Figure 286 (Postflight). This photograph is of the area beneath the cover without cable. The far side wall and the bottom of the tray appeared wet with brown contamination along the cover edges.

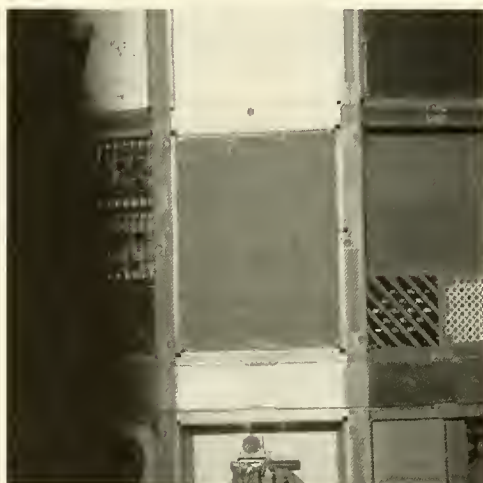
Figure 287 (In Flight). The thermal cover appears to be without physical damage, but it is more taut than in the prelaunch photograph. The glossy blue appearance of the thermal cover in this photograph is apparently caused by the lighting conditions and not by a change in the material optical properties. A few white dots and circular indentations are probably impact on or penetrations of the thermal cover. Velcro attachment pads are evident.

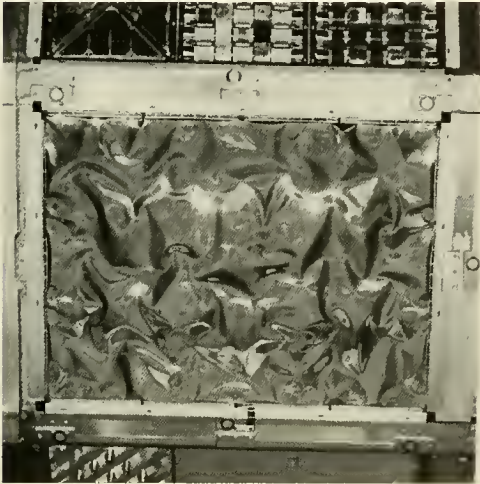
Figure 288
Photo No: KSC-390C-1066.09
Dup. Neg. No.: L90-13478
LISAR No.: EL-1994-00188
Photo Credit: KSC
Photo Date: 2/8/90
Location: KSC SAEF II
Subject: Postflight Survey of Tray D1

Figure 288 (Postflight). The thermal cover appears specular and no change from in-flight condition is indicated. The bright irregular discoloration located above the grounding strap at about one-third of the height of the thermal cover from the bottom edge did not appear in the in-flight photograph. The discoloration appears to be a piece of material from a degraded experiment that has become attached to the cover. The cover has numerous white dots that may also be debris from other degraded experiments. The cover is less taut than in the in-flight photograph, but the locations of the Velcro attachment pads are still evident.

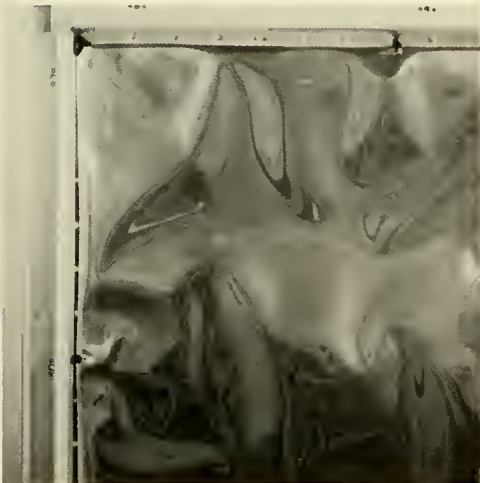
Figure 289
Photo No: KSC-390C-2284.05
Dup. Neg. No.: L91-9292
LISAR No.: EL-1994-00567
Photo Credit: KSC
Photo Date: 3/23/90
Location: KSC SAEF II
Subject: Postflight Detail of Upper Left of Tray D1

Figure 289 (Postflight). This photograph is of the upper left one-sixth of the tray. The thermal cover appears specular with no apparent damage. The reflective properties of the uneven surface of the cover result in various light and color patterns. The locations of the Velcro attachment pads are obvious. A few impact or penetration discolorations and small debris from nearby degraded experiments are visible.

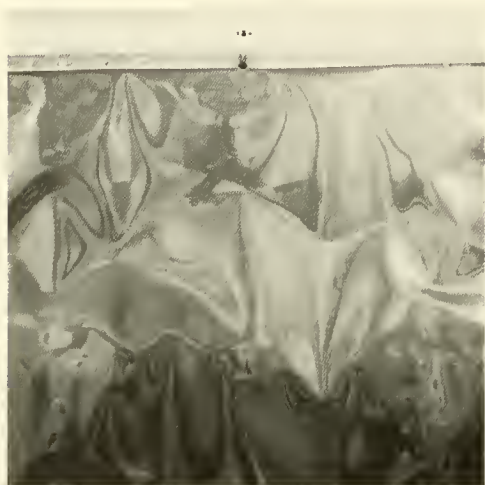
Figure 290 (Postflight). This photograph is of the upper center one-sixth of the tray. The thermal cover appears specular with no apparent damage. The reflective properties of the uneven surface of the cover result in various light and color patterns. The locations of the Velcro attachment pads are obvious. A few impact or penetration discolorations and small debris from nearby degraded experiments are visible.

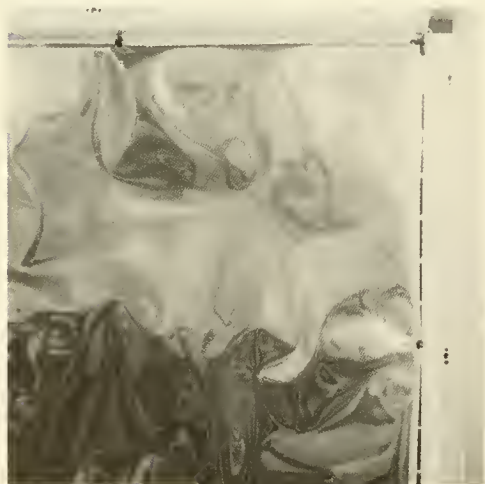
Figure 291 (Postflight). This photograph is of the upper right one-sixth of the tray. The thermal cover appears specular with no apparent damage. The reflective properties of the uneven surface of the cover result in various light and color patterns. The locations of the Velcro attachment pads are obvious. A few impact or penetration discolorations and small debris from nearby degraded experiments are visible.

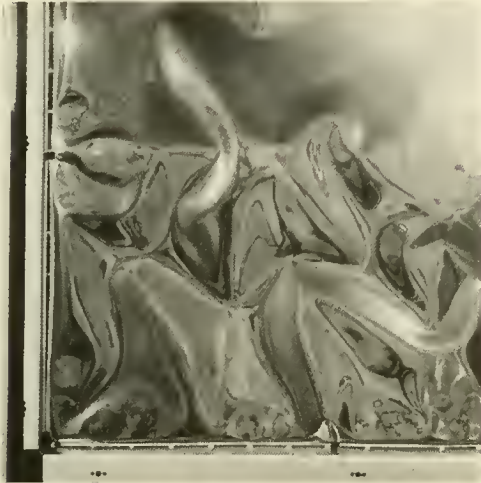
Figure 292 (Postflight). This photograph is of the lower left one-sixth of the tray. The thermal cover appears specular with no apparent damage. The reflective properties of the uneven surface of the cover result in various light and color patterns. The locations of the Velcro attachment pads are obvious. A few impact or penetration discolorations and small debris from nearby degraded experiments are visible.

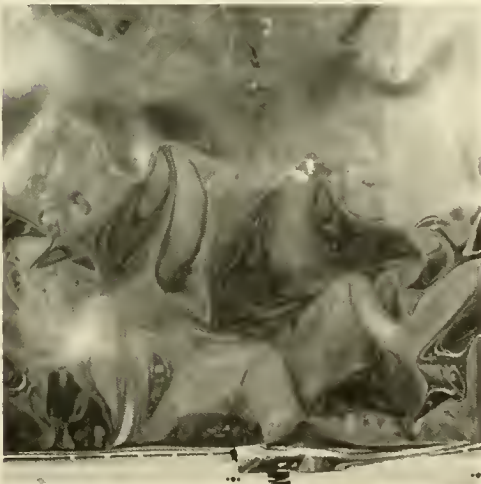
Figure 293 (Postflight). This photograph is of the lower center one-sixth of the tray. The thermal cover appears specular. The tear in the lower center of the cover occurred during tray removal. The reflective properties of the uneven surface of the cover result in various light and color patterns. The locations of the Velcro attachment pads are obvious. A few impact or penetration discolorations and small debris from nearby degraded experiments are visible.

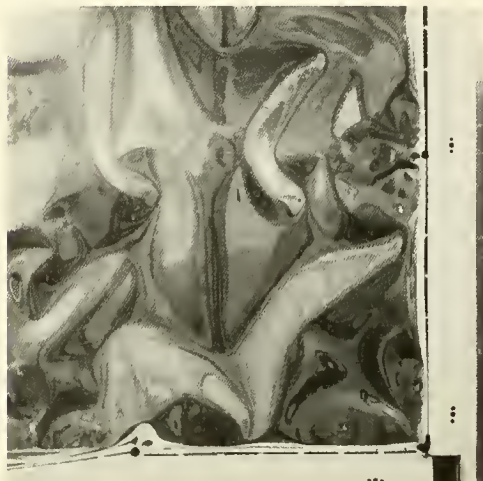
Figure 294 (Postflight). This photograph is of the lower right one-sixth of the tray. The thermal cover appears specular with no apparent damage. The reflective properties of the uneven surface of the cover result in various light and color patterns. The locations of the Velcro attachment pads are obvious. A few impact or penetration discolorations and small debris from nearby degraded experiments are visible.

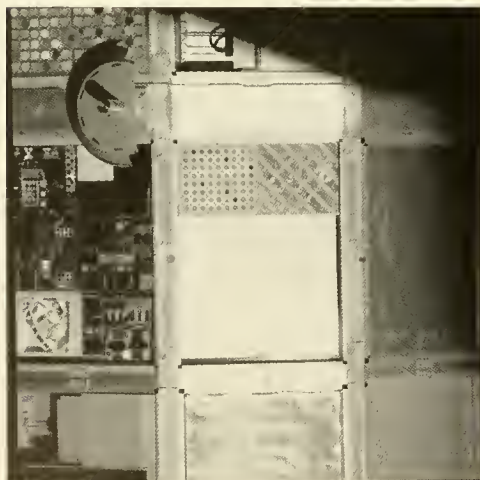
Figure 296
Photo No.: S32-89-013
Dup. Neg. No.: L90-10495
LISAR No.: EL-1994-00130
Photo Credit: JSC
Photo Date: 1/12/90
Location: In Flight
Subject: In-Flight Survey of Tray D2

Figure 296 (In Flight). The aluminum mounting plate of experiment AO172, which was painted with Chemglaze II A-276 white paint, is now a uniform brown as are the diagonal stripes on experiment AO189. Light reflections appear on the unpainted stripes of experiment AO189. Reflected light obscures any color definition of the panels of experiment S0001.

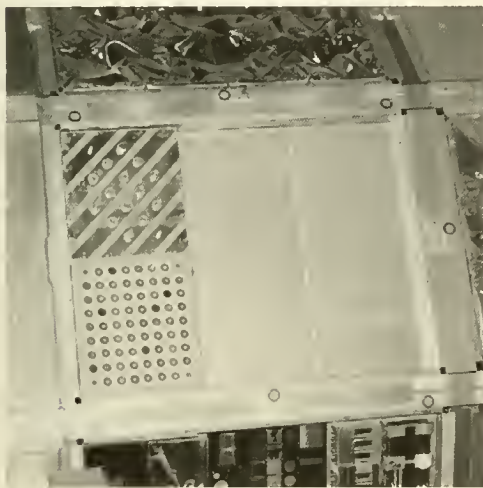
Figure 297
Photo No.: KSC-390C-731.11
Dup. Neg. No.: L92-17662
LISAR No.: EL-1994-00165
Photo Credit: KSC
Photo Date: 2/1/90
Location: KSC O & C building
Subject: Postflight Survey of Tray D2

Figure 297 (Postflight). The surfaces of experiments AO172 and AO189 that were painted with Chemglaze II A-276 white paint are now a uniformly discolored tan. The faint patterns in experiment S0001 panels were observed in preflight.

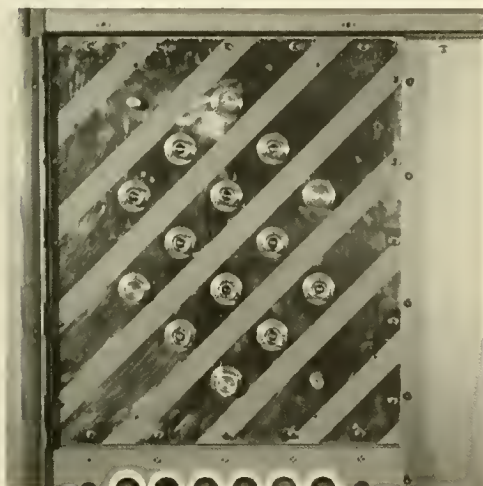
Figure 298
Photo No.: KSC-390C-2038.06
Dup. Neg. No.: L91-9265
LISAR No.: EL-1994-00462
Photo Credit: KSC
Photo Date: 3/16/90
Location: KSC SAEF II
Subject: Postflight Detail of Upper Left of Tray D2

Figure 298 (Postflight). This photograph is of the upper left one-sixth of the tray. The sensors appear undamaged, but the paint strips that were white before flight are now tan. Light reflections make imperfections in the surface finish that existed before flight more visible.

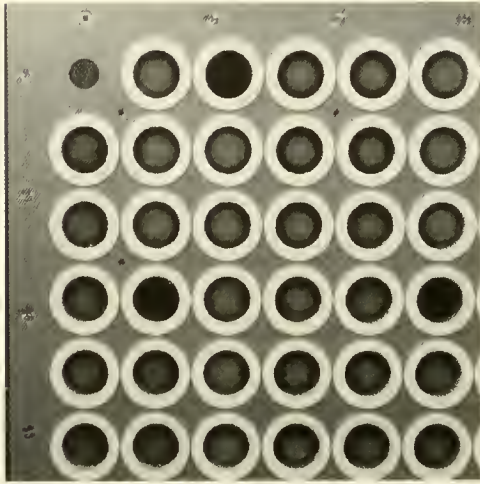
Figure 299 (Postflight). This photograph is of the lower left one-sixth of the tray. The sensors appear undamaged, but the white paint on the baseplate is now tan.

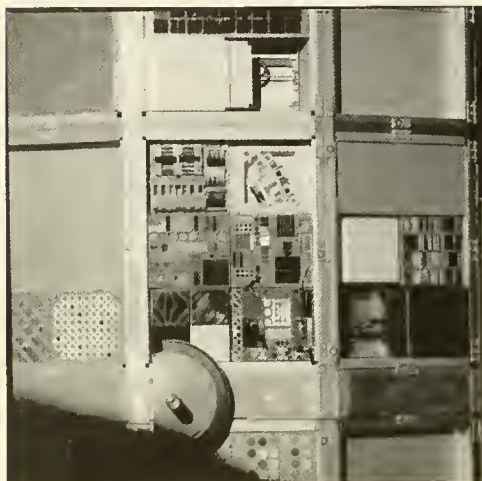
Figure 301
Photo No.: S32-89-008
Dup. Neg. No.: L90-10494
LISAR No.: EL-1994-00129
Photo Credit: JSC
Photo Date: 1/12/90
Location: In Flight
Subject: In-Flight Survey of Tray D3

Figure 301 (In Flight). Experiment M0003 appears to be in good condition except that approximately half of the thin-film polymers in the lower right tray section are loose at one end. Other material samples seem intact, but they appear discolored. Experiment M0002-1 appears to be without physical damage, but it has a light tan discoloration on the detector housings and the surfaces of the experiment support structure.

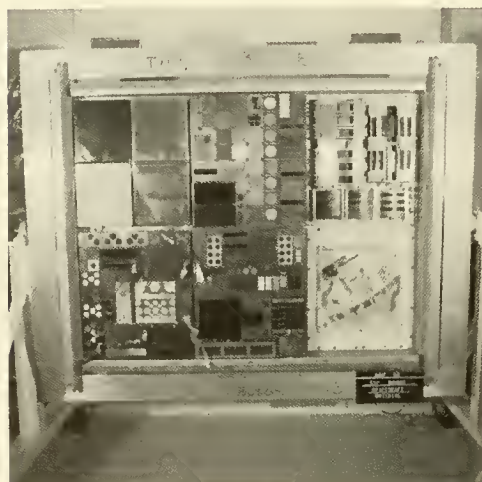
Figure 302
Photo No.: KSC-390C-1485.05
Dup. Neg. No.: L91-9252
LISAR No.: EL-1994-00210
Photo Credit: KSC
Photo Date: 2/28/90
Location: KSC SAEF II
Subject: Postflight Survey of Tray D3

Figure 302 (Postflight). No significant differences from in-flight conditions are apparent. Many experiment specimens and mounting hardware are discolored. The damaged thin-film polymers in the lower left are still attached. Other parts of the experiments appear intact.

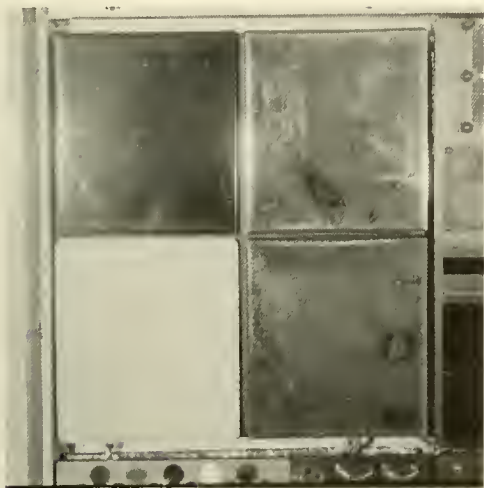
Figure 303 (Postflight). This photograph is of the upper left one-sixth of the tray. The metallized and coated polymers appear to have survived the exposure intact, but discolorations are apparent.

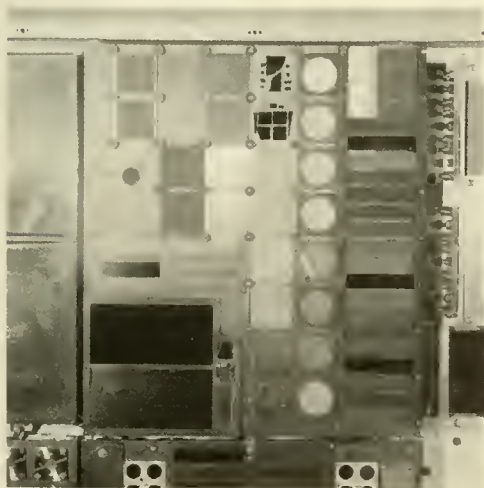
Figure 304 (Postflight). This photograph is of the upper center one-sixth of the tray. Most test specimens appear intact, but there appears to be significant brown discoloration on specimens and specimen mounting hardware. Composite material samples located in upper right, upper center, and lower center remain intact, but they are bleached or discolored.

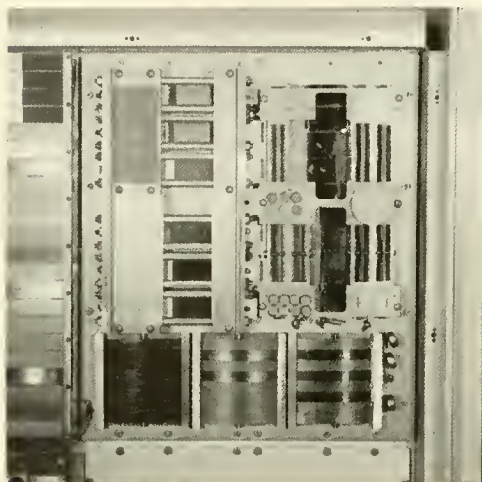
Figure 305 (Postflight). This photograph is of the upper right one-sixth of the tray. Most test specimens appear intact, but there seems to be significant brown discoloration on specimens and specimen mounting hardware. Composite material samples located in upper right, upper center, and lower center remain intact, but they are bleached or discolored.

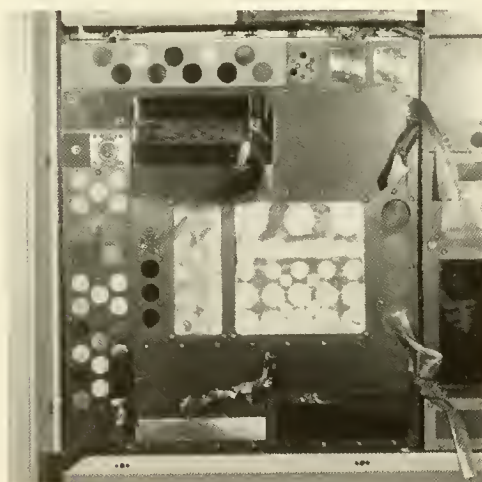
Figure 306 (Postflight). This photograph is of the lower left one-sixth of the tray. Many of the thin-film polymers are loose at one end. The Teflon covers and the large square and the rectangle in the center appear to remain intact; however, they have changed from silver to milky white where components are located beneath them and to a gold color where there are no components. Surfaces and mounting hardware appear to have significant brown discoloration.

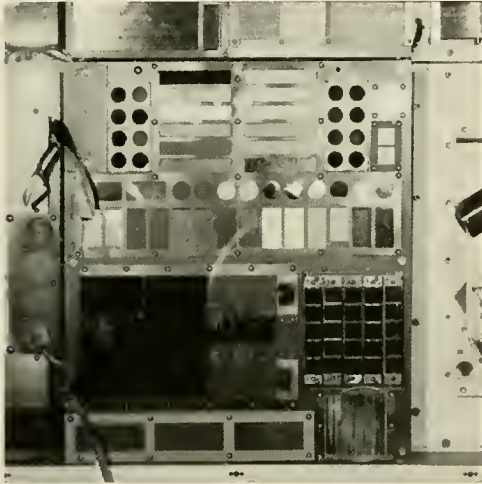
Figure 307 (Postflight). This photograph is of the lower center one-sixth of the tray. Most test samples appear intact, but samples and mounting hardware have extensive discolorations. Composite material samples that are located in the upper right, the upper center, and the lower center remain intact, but they are bleached or discolored.

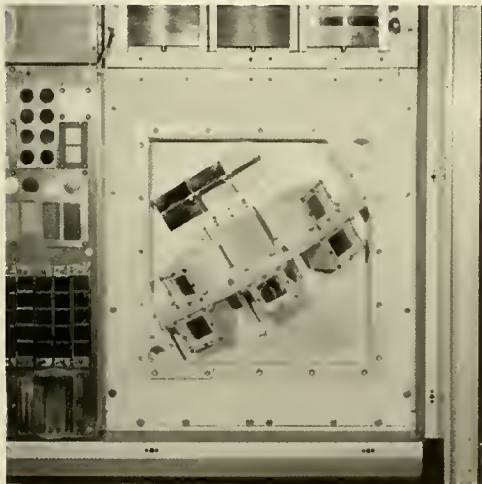
Figure 308 (Postflight). Experiment M0002-1 in the lower right one-sixth of the tray appears intact, but it is a somewhat uniform tan rather than white, which was the color it was painted before flight.

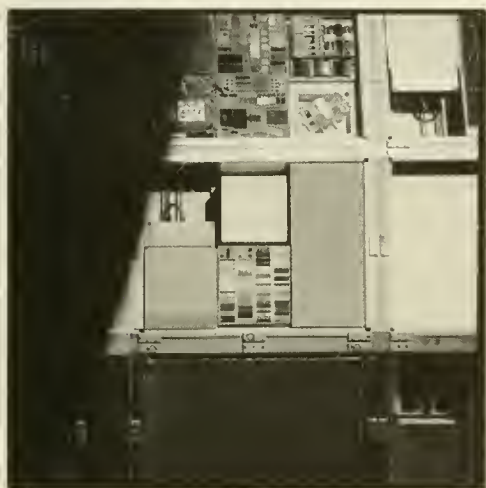
Figure 310
 Photo No.: S32-89-004
 Dup. Neg. No.: L90-10493
 LISAR No.: EL-1994-00128
 Photo Credit: JSC
 Photo Date: 1/12/90
 location: In Flight
 Subject: In-Flight Survey of Tray D4

Figure 310 (In Flight). The Chemglaze II A-276 white paint on the EPDS cover has changed to a medium brown and the IITRI S13G-LO white paint has become light tan or off-white. Colors of the composite material samples are bright and clear. Some material samples appear to be blue in this photograph, although they did not in prelaunch or postflight photographs. The mounting plate of the composite materials experiment has discolorations that vary from a light tan to a medium brown. The rectangular aluminum cover plate located in the upper center of the experiment is a uniform light brown. The thermal covers on the EECC appear to have changed to lavender or purple in this photograph; however the covers maintain the color of anodized aluminum in postflight photos. The dark square discolorations on the upper corners of the thermal cover are pads of tape used to cover exposed sharp corners. The pads were not in place in the prelaunch photograph.

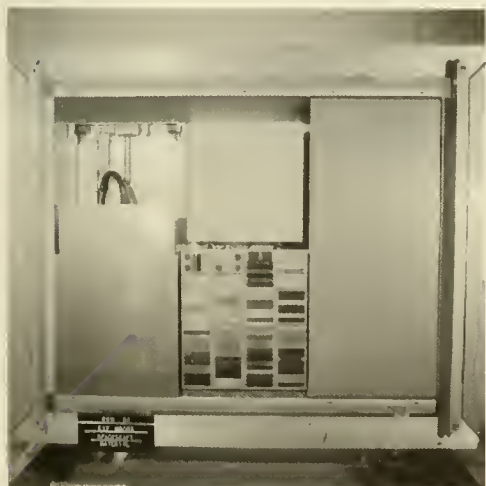
Figure 311
 Photo No.: KSC-390C-1478.03
 Dup. Neg. No.: L91-9173
 LISAR No.: EL-1994-00202
 Photo Credit: KSC
 Photo Date: 2/28/90
 Location: KSC SAEF II
 Subject: Postflight Survey of Tray D4

Figure 311 (Postflight). Light reflections cause details to be less clear than in the in-flight photograph. The painted covers are discolored and the composite materials experiment mounting plate has discolorations that vary from light tan to medium brown.

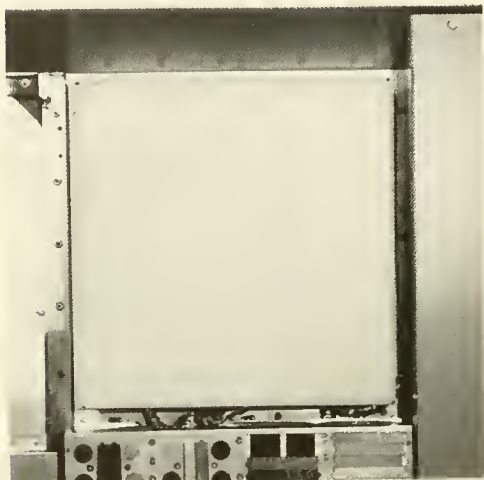
Figure 312 (Postflight). This photograph is of the upper center one-sixth of the tray. The signal conditioning unit thermal cover that was painted with IITRI SI3G-LO white paint has become light tan or off-white.

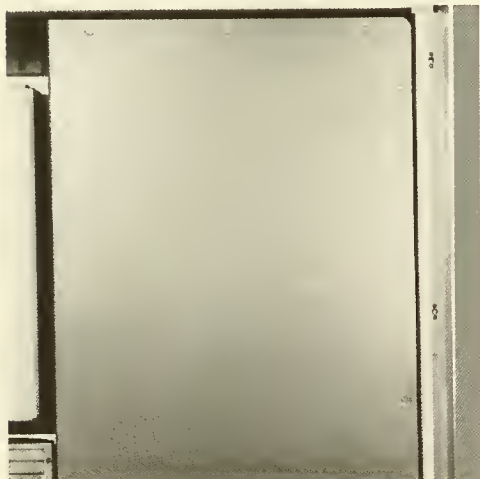
Figure 313 (Postflight). This photograph is of the upper right one-sixth of the tray. The Chemglaze II A-276 white paint on the EPDS cover has turned from white to uniform brown.

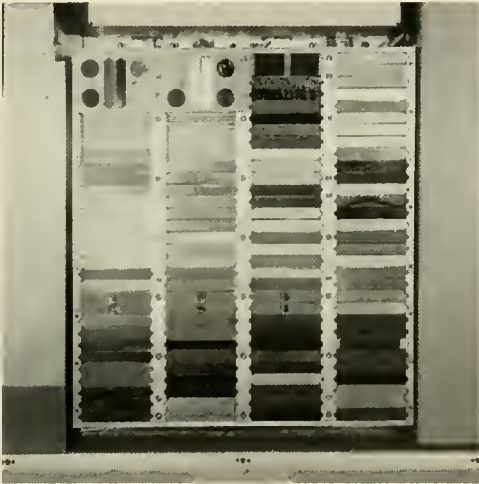
Figure 314
Photo No.: KSC-390C-1478.12
Dup. Neg. No.: L91-9182
LISAR No.: EL-1994-00036
Photo Credit: KSC
Photo Date: 2/28/90
Location: KSC SAEF II
Subject: Postflight Detail of Lower Center of
Tray D4

Figure 314 (Postflight). This photograph is of the lower center one-sixth of the tray. Many test specimens have changed color and some show signs of degradation. Some mounting hardware shows discoloration.

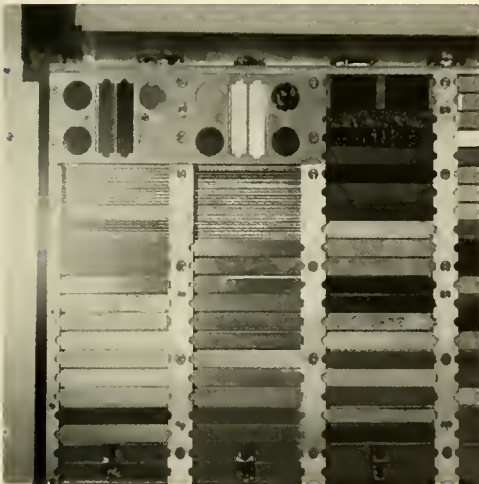
Figure 315
Photo No.: KSC-390C-1480.07
Dup. Neg. No.: L91-9189
LISAR No.: EL-1994-00046
Photo Credit: KSC
Photo Date: 2/28/90
Location: KSC SAEF II
Subject: Postflight Detail of Upper Left of Lower
Center of Tray D4

Figure 315 (Postflight). This close-up photograph is of the upper left of the lower center one-sixth of the tray. Many test specimens have changed color and some show signs of degradation. Some mounting hardware shows discoloration.

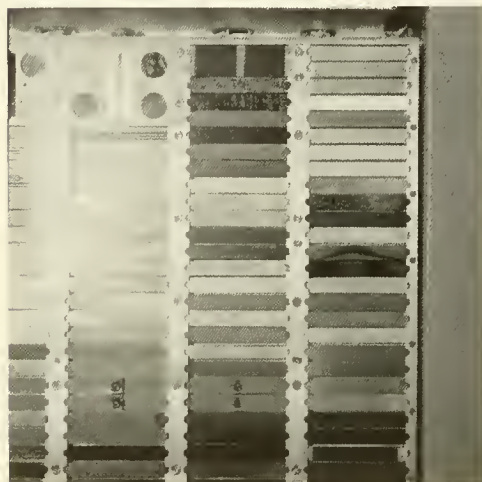
Figure 316 (Postflight). This close-up photograph is of the upper right of the lower center one-sixth of the tray. Many test specimens have changed color and some show signs of degradation. Some mounting hardware shows discoloration. The colors in the upper left area are somewhat washed out because of the lighting.

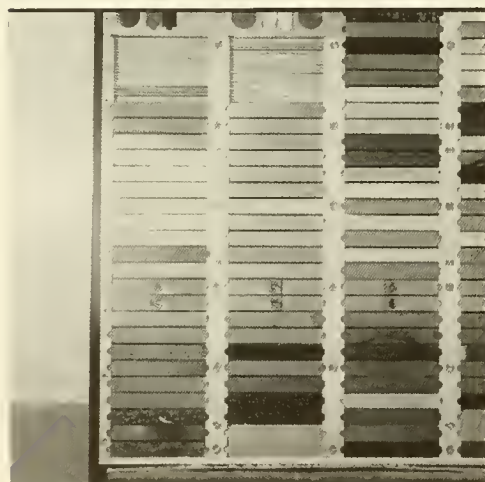
Figure 317 (Postflight). This close-up photograph is of the lower left of the lower center one-sixth of the tray. Many test specimens have changed color and some show signs of degradation. Some mounting hardware shows discoloration.

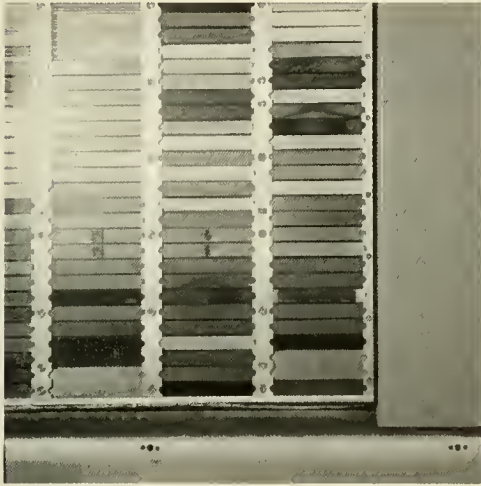
Figure 318 (Postflight). This close-up photograph is of the lower right of the lower center one-sixth of the tray. Many test specimens have changed color and some show signs of degradation. Some mounting hardware shows discoloration.

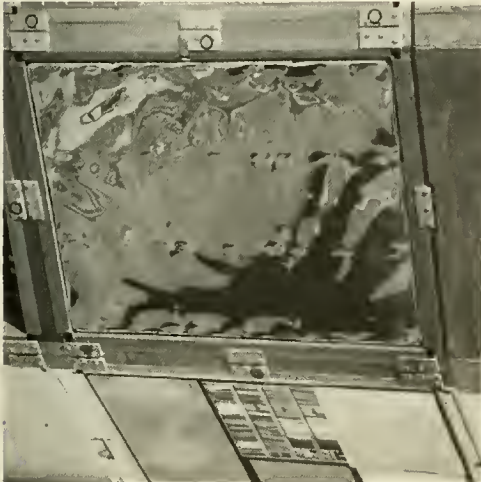
Figure 320
Photo No.: S32-82-017
Dup. Neg. No.: L90-10456
LISAR No.: EL-1994-00038
Photo Credit: JSC
Photo Date: 1/12/90
Location: In Flight
Subject: In-Flight Survey of Tray D5

Figure 320 (In Flight). The thermal cover appears to be without physical damage, but it is more taut than in the prelaunch photograph. The glossy blue-black appearance of the thermal cover in this photograph is due to lighting conditions and not to a change in the material optical properties. The oblong indentations in the thermal cover are in areas where Velcro pads are bonded to the back of the cover. The irregular discolorations on the cover surface are from lighting and reflections. The white dots and the circular indents in the right center of the cover may be impact locations. The ground strap appears to be in place and to have no visible damage.

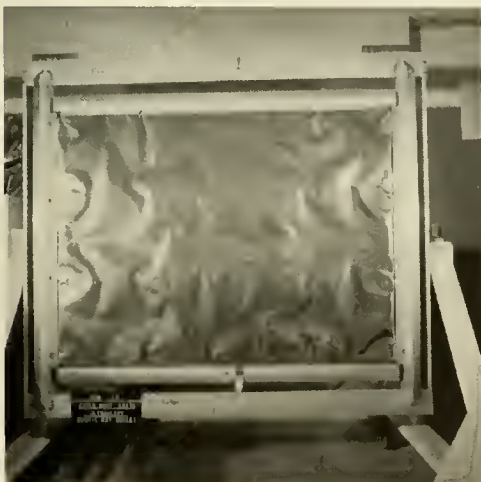
Figure 321
Photo No.: KSC-390C-2277.10
Dup. Neg. No.: L91-10204
LISAR No.: EL-1994-00311
Photo Credit: KSC
Photo Date: 3/23/90
Location: KSC SAEF II
Subject: Postflight Survey of Tray D5

Figure 321 (Postflight). The thermal cover appears specular with no apparent damage. A vertical strip of discoloration that is approximately 6-in. wide with a grainy pattern extends from top to bottom along the left side of the thermal cover. This discoloration was visible prior to flight. The cover appears less taut than in the in-flight photograph and locations of the Velcro attachment pads are not as prominent. The ground strap appears to be in place with no visible damage; however, the color appears darker than in the prelaunch photograph.

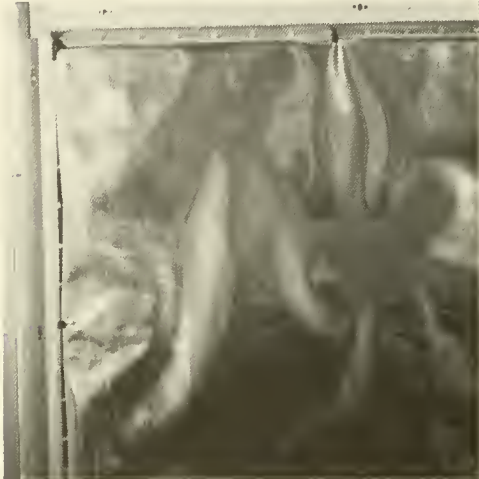
Figure 322 (Postflight). This photograph is of the upper left one-sixth of the tray. The grainy pattern in the surface finish, which is visible in the light reflection was on the material prior to flight. The thermal cover appears specular with no apparent damage. The reflective properties of the uneven surface of the cover result in various light and color patterns. The locations of the Velcro attachment pads are visible.

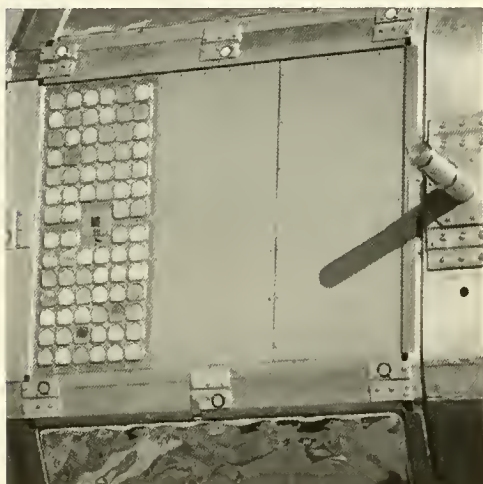
Figure 329 (In Flight). During the mission, the tray surface was at an angle of approximately 82° to the orbital velocity vector, and therefore it was exposed to a higher atomic oxygen flux than if it had been parallel with the velocity vector. Note the difference in color of the paint dots on the tray clampblocks; there are white dots along the top edge, a light tan dot in the center, and dark brown dots along the bottom of the photograph. This color change illustrates the transition from the leading to the trailing sides. Experiment AO201, which is located in the left side of the tray, seems to have a thin coat of the brown contamination stain. The detectors show reflections of the sky and the cargo bay liner in the mirrorlike surfaces. The SDI plates show fingerprints and a palm print that occurred during installation of the panels. These prints are not visible on the preflight photograph.

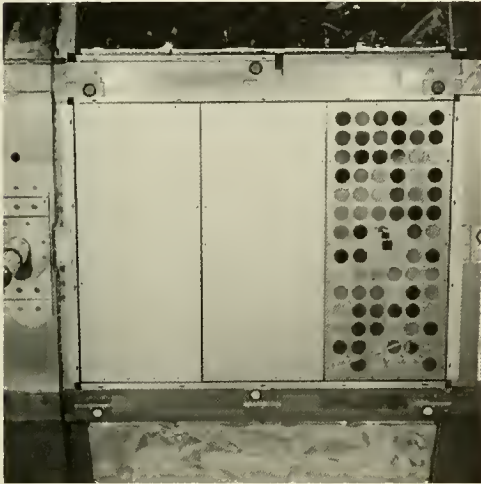
Figure 330
Photo No.: KSC-390C-1033.10
Dup. Neg. No.: L90-13440
LISAR No.: EL-1994-00180
Photo Credit: KSC
Photo Date: 2/9/90
Location: KSC SAEF II
Subject: Postflight Survey of Tray D6

Figure 330 (Postflight). The direction and the intensity of the artificial light source caused reflections that tended to wash out the brown stain on the aluminum structure. Experiment AO201 appears to be in excellent condition in the postflight photograph. All bond joints seem to have survived the space environment and the experiment hardware is intact. The blue in the metallic surface of the detectors is caused by reflections of the surrounding area. The white stripe running diagonally across the bottom two rows of detectors is the reflection of a safety control rope that restricted access to the LDEF.

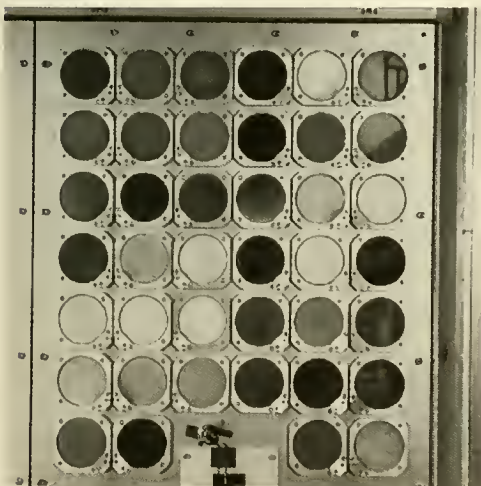
Figure 331
Photo No.: KSC-390C-2070.11
Dup. Neg. No.: L91-10235
LISAR No.: EL-1994-00479
Photo Credit: KSC
Photo Date: 3/19/90
Location: KSC SAEF II
Subject: Postflight Detail of Upper Right of Tray D6

Figure 331 (Postflight). This photograph is of the upper right one-sixth of the tray. The different colors of the detectors are due to reflections of surrounding areas. Some small impacts on the sensors are visible. There is some discoloration of the mounting hardware and the baseplate.

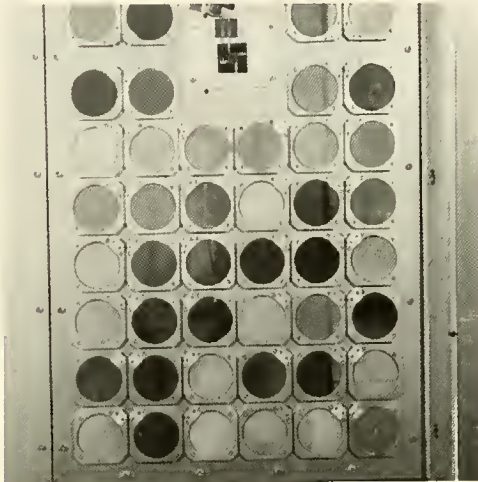
Figure 332 (Postflight). This photograph is of the lower right one-sixth of the tray. The different colors of the detectors are due to reflections of surrounding areas. Some small impacts on the sensors are visible. There is some discoloration of the mounting hardware and baseplate.

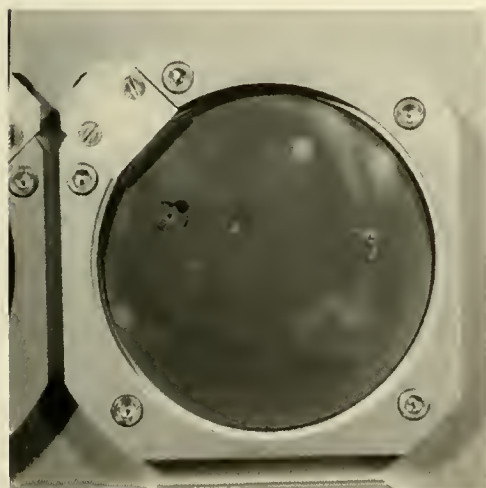
Figure 335 (Postflight). This close-up photograph is of a sensor and shows an impact crater. The sensor is located at the lower left corner of the solar cell baseplate. Other areas on the sensor also indicate impacts.
